BIOFILM REMOVAL

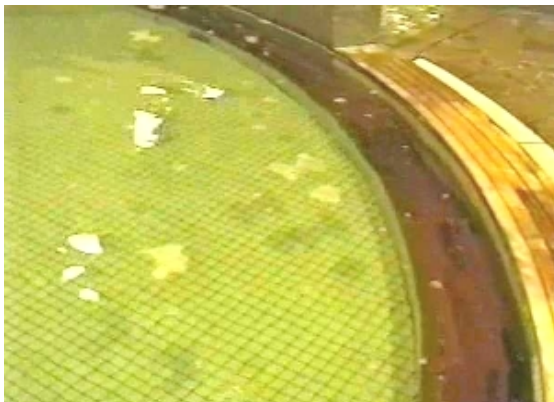
INONO HOT SPRINGS

Biofilm removal started within hours after MIOX system start-up

Upon conversion to mixed oxidants, sloughing was immediately apparent as particles of biofilm began to appear on the pool surface. Operators manually removed the biofilm and within one week of operation, the pool water was clear.

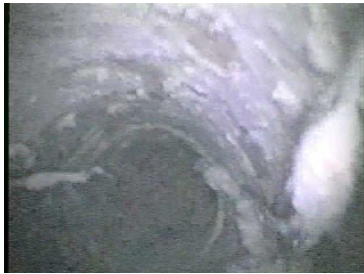
FEED WATER PIPE

Feed water pipe with sodium hypochlorite

Even more impressive was the videotape showing biofilm removal in the 4-inch pipelines. In the feed water pipe, substantial removal was evident after 6 days, and during the last videotaping at

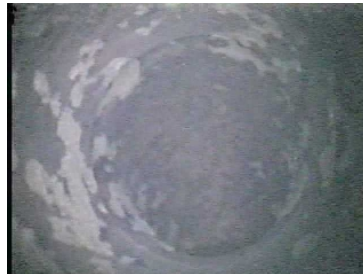
After 6 days with mixed oxidants

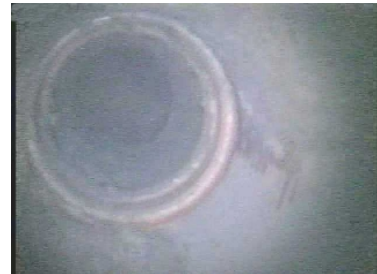
After 22 days with mixed oxidants

22 days, removal of biofilms was total. The same phenomenon occurred in the filter recirculation pipe with the entire filamentous mass completely eliminated.

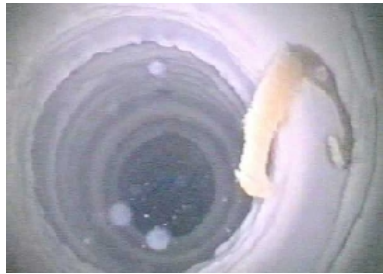
FILTER RECIRCULATION PIPE

With sodium hypochlorite

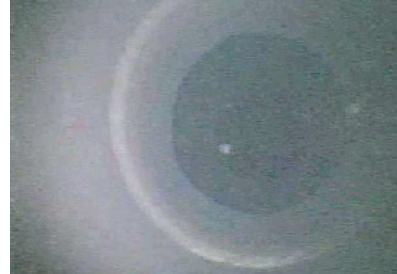
With mixed oxidants

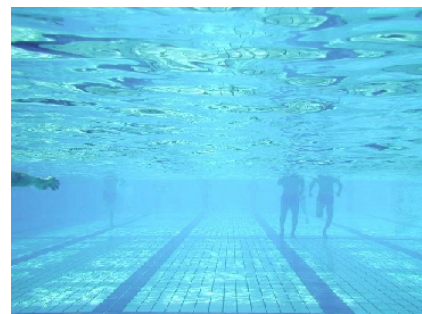
With mixed oxidants

Installations at Shibasaki Gymnasium in Tachikawa City and Miwa Town in the Aichi Prefecture of Japan, both initially using sodium hypochlorite disinfection, reported drastically improved clarity of the water after only 4-5 days of operation with MIOX mixed oxidants. Improved water clarity indicates a removal of biofilm contamination and/or algae growth responsible for the cloudiness in the water.

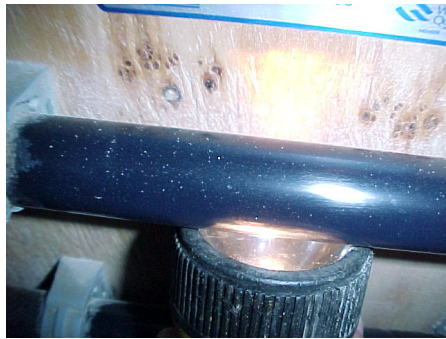
Black biofilm coating before application of mixed oxidants

In an unrelated study, Charles Smith of Quality Water Systems installed a small MIOX system on a bakery cooling tower for a pilot test.⁶ Upon start of the test, the clear pipelines were completely obscured by a “leathery” black slime. Previous disinfection with hypochlorite had minimal impact on the biofilm contamination, and the pipes required cleaning within 10 days after disinfection was stopped. In contrast, mixed oxidants thoroughly broke down the biofilm. When the MIOX pilot system was removed, the bakery owners reported that it took 3 weeks for the biogrowth to reform, and even at that point, the “leathery” texture was not apparent, so cleaning was unnecessary. Mixed oxidants removed even the tough substrate that allows more rapid regrowth of biofilm.

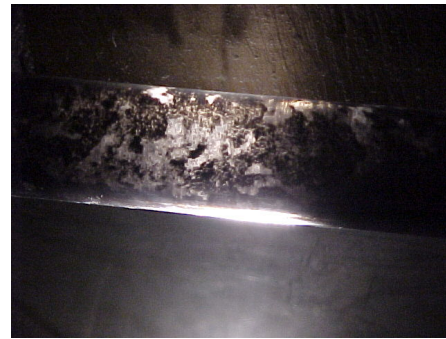
Breakdown of biofilm begins with mixed oxidants

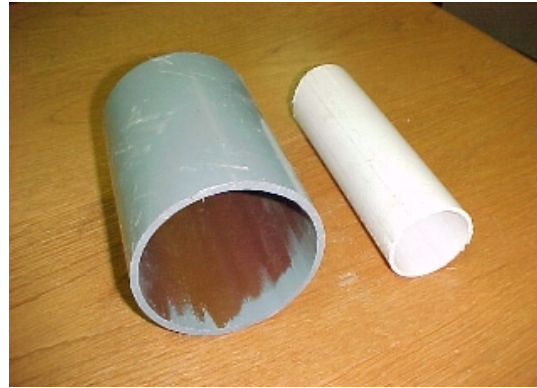
Biofilm contamination on chlorine-treated line (left) versus mixed-oxidant line (right) at Diana Water Supply

Diana Water Supply in Texas has a number of well sites and has been gradually converting from chlorine gas disinfection to MIOX mixed-oxidant generation, beginning in 1996. Several years ago, two line breaks occurred around the same time, one on a line treated with chlorine gas and the other on a line treated with mixed oxidants. Both pipelines had been in use for more than ten years, and both were originally on chlorine gas. The conversion to mixed oxidants on the second line had taken place about one year prior to the line break. The chlorine treated

line was only 200 feet from the disinfection station, yet it was coated with a brown slimy substance. In contrast, the mixed-oxidant treated line was half a mile from the disinfection station, but the line was completely clean.
